AIRCRAFT ACCIDENT REPORT

WORLD AIRWAYS INC., FLIGHT 32,
MCDONNELL DOUGLAS DC-10-30CF, N112WA,
OVER NORTH ATLANTIC OCEAN
SEPTEMBER 20, 1981

NTSB-AAR-82-1
C. 2

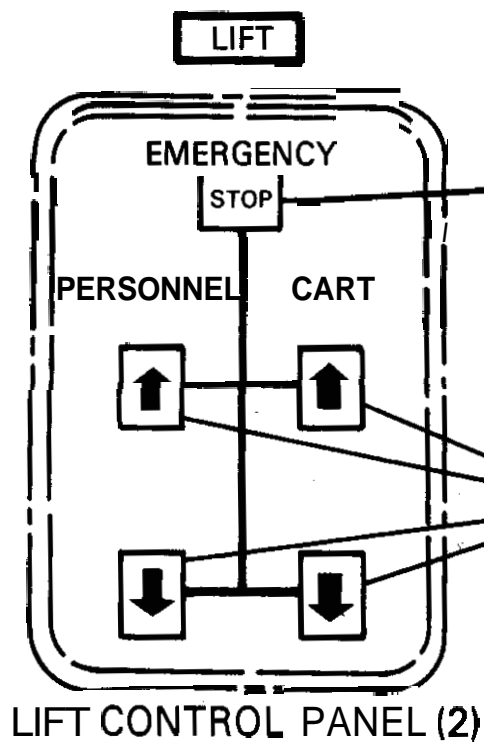
Figure 2.--Personnel and cart lifts.

The lower galley personnel lift door frame was deformed and battered in the area where the electrical interlock switches are mounted (see figure 2). The uppermost electrical interlock switch on the lower galley personnel lift door, S1-450 (see figure 1), was found with the switch roller assembly twisted and the roller striker arm jammed in the depressed (switch closed) position. The damage to the lower galley lift door frames was the result of repeated bumping by food and liquor carts.

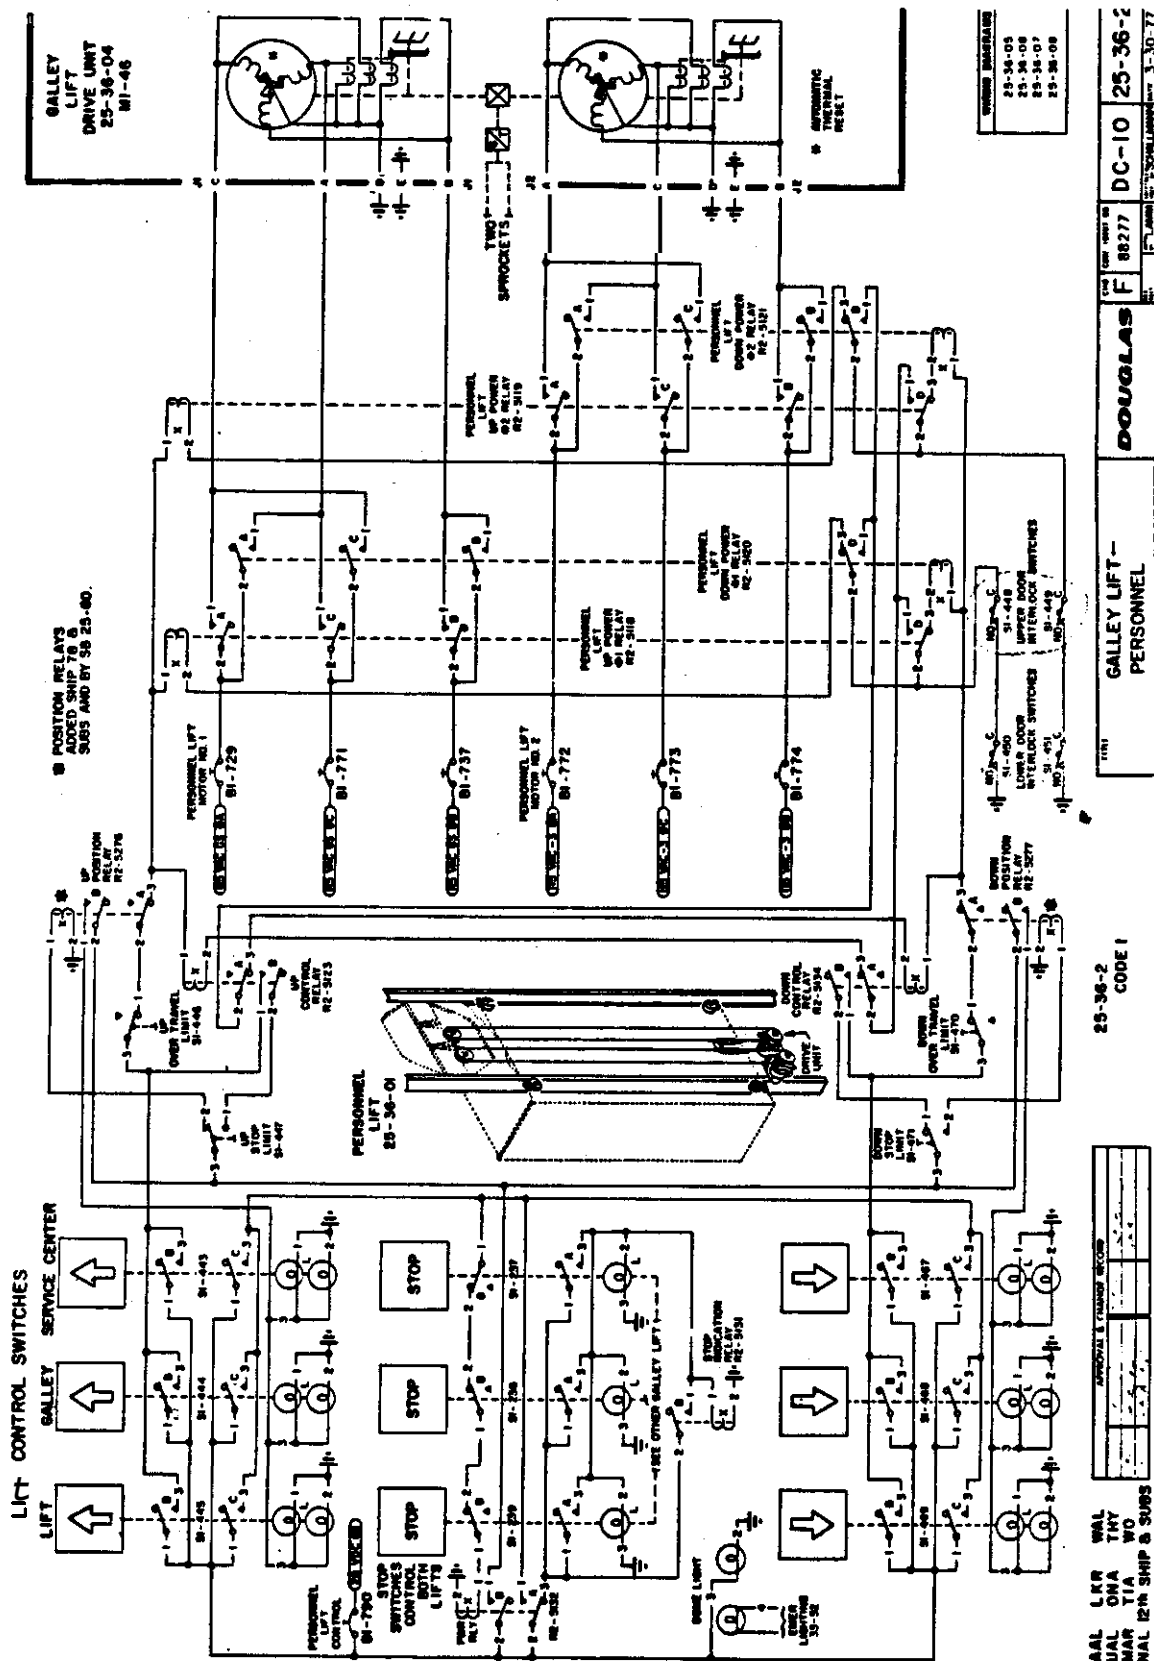
Figure 4.—Electrical diagram of galley personnel lift system.

Alternate Circuit - Each lift has two independent circuits to provide power to the system. Normally, both circuits operate; however, if an electrical malfunction occurs in one of the two circuits, the system should continue to operate at half (or partial) speed, thus allowing continuation of food service. Each system has its own set of upper and lower door interlock switches and its own up and down power relay. In addition, these components in each system are wired to up and down control relays common to both system. (See figure 4.)
